MYCONCRETE

THE BULLETIN OF THE AMERICAN CONCRETE INSTITUTE - MALAYSIA CHAPTER
(E-bulletin)

ACI Malaysia Chapter | August 2023

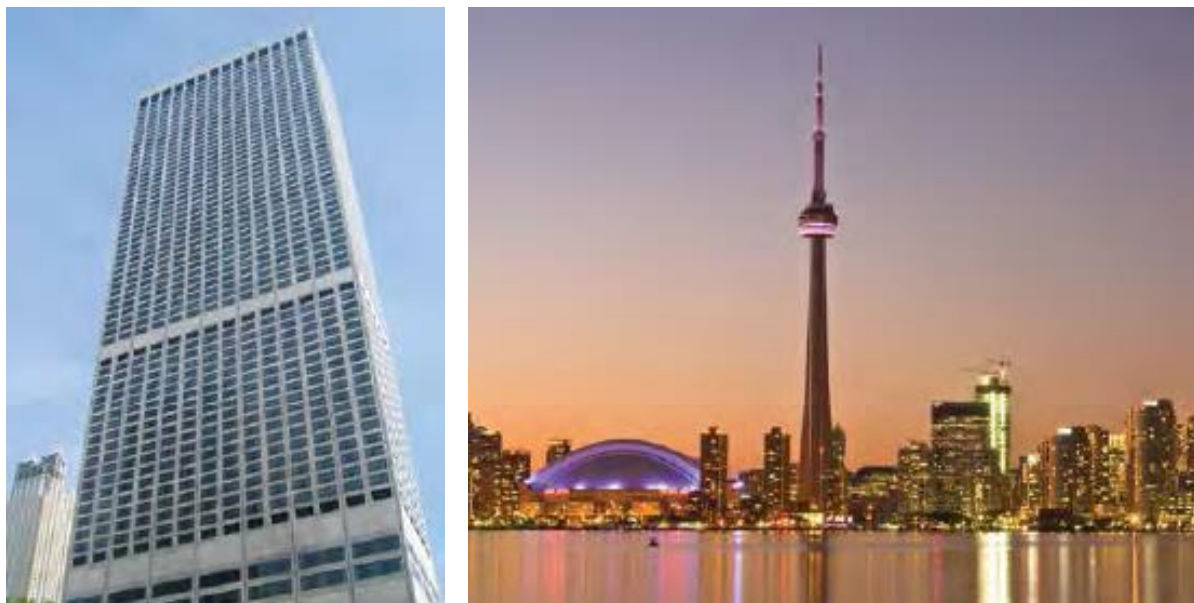
Fig. 1: High-rise buildings constructed before 1975: (a) Water Tower Place (photo credit: © Jeremy Atherton); and (b) the CN Tower (photo courtesy of Benson Kua)

Until the recent construction of Burj Kalifa, the CN Tower, Toronto, ON, Canada, was the highest freestanding concrete structure in the world at 482 m (1581 ft), as shown in Fig. 1(b). The tower was built using slipforms and an air-entrained concrete having an average compressive strength of 55 MPa (7980 psi).⁴ The concrete had to be air-entrained to be resistant to freezing and thawing. The tower was built continuously from the beginning of May to the end of November, with ambient temperatures as high as 35°C (95°F) and as low as -10°C (14°F). Because the walls were 2.1 m (6 ft 10 in.) thick at the base of the tower, cement with a low heat of hydration had to be used to limit thermal gradients. Normal portland cement was then progressively substituted for the initial low-heat-of-hydration cement as the weather was getting colder and colder while the structure was rising. Accelerated tests were also used to control concrete compressive strength during construction.

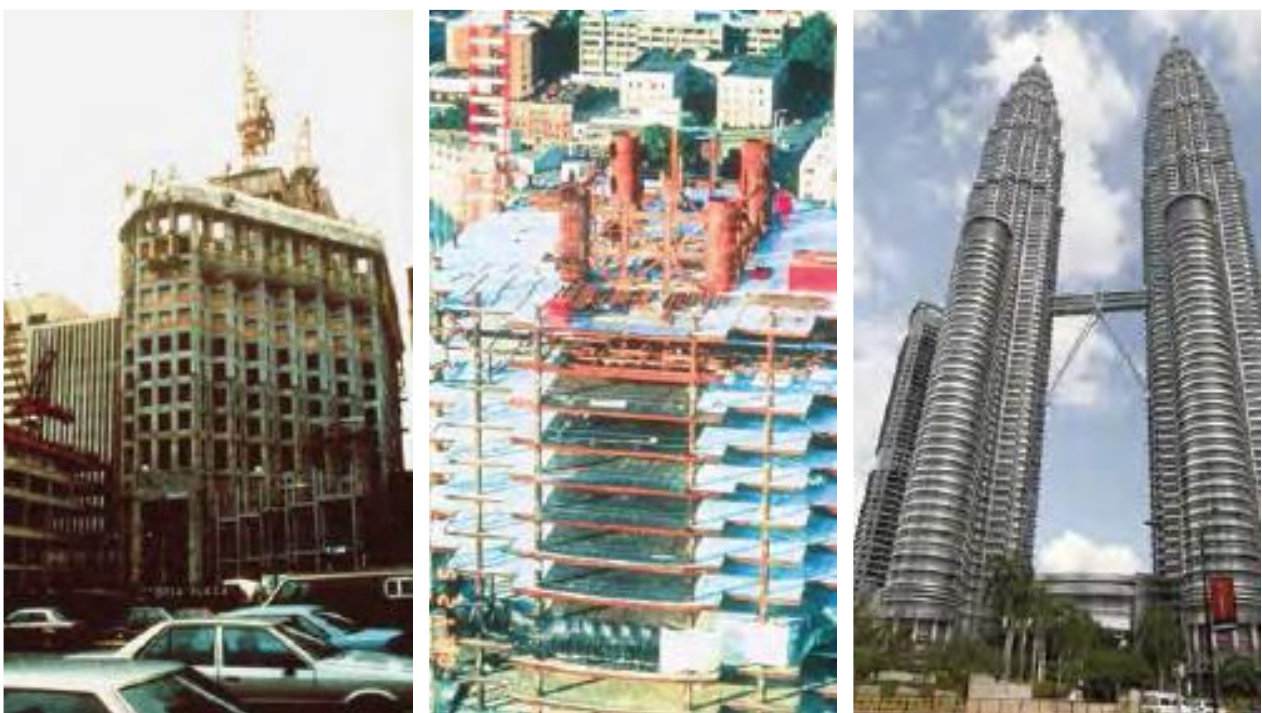
Fig. 2: High-rise building constructed with HRWRAs: (a) construction of Scotia Plaza (photo courtesy of John Bickley); (b) construction of Two Union Square (photo courtesy of Weston Hester); and (c) the Petronas Towers (photo courtesy of Morio and Wikimedia Commons)

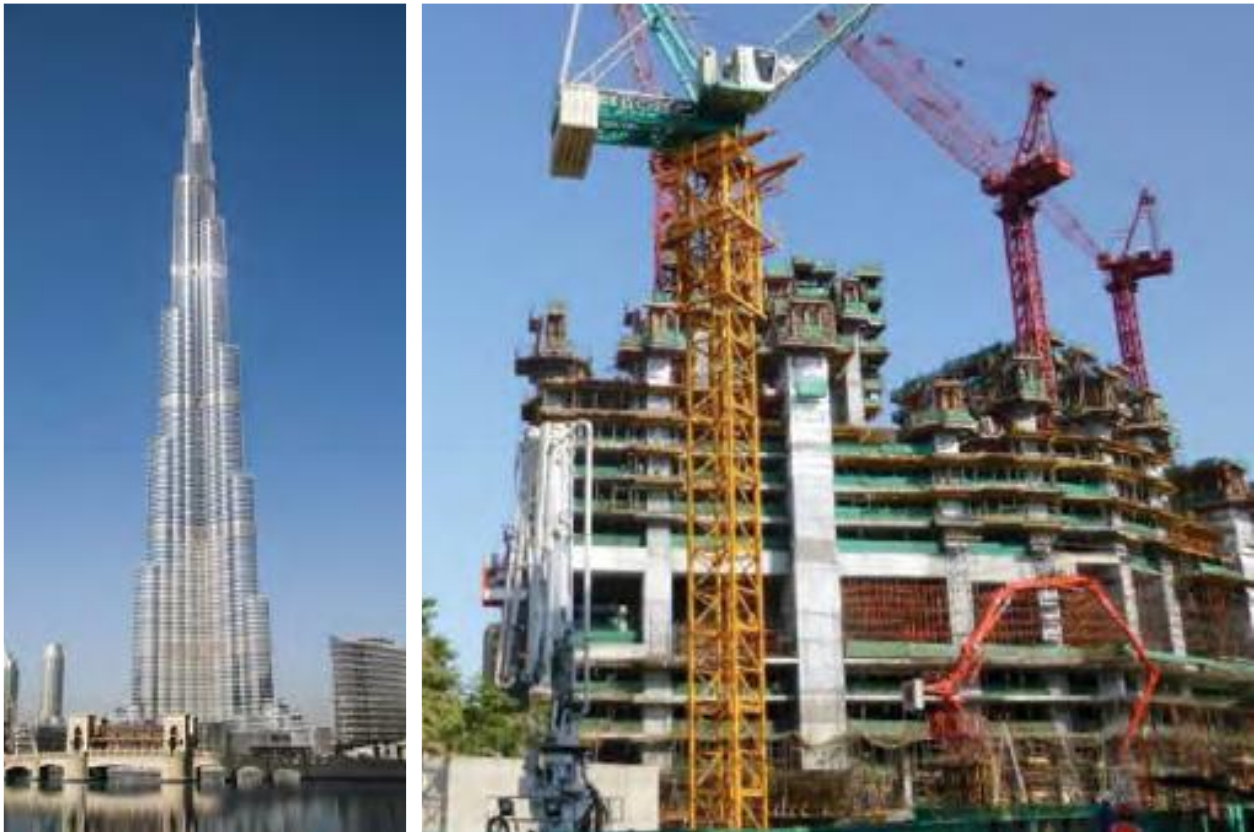
Fig. 3: Tallest high-rise buildings: (a) Burj Khalifa; and (b) construction of the Worli Project (photo courtesy of Pierre-Claude Aïtcin)

Burj Khalifa, Dubai, the United Arab Emirates (Fig. 3(a)), at 828 m (2717 ft) high, is currently the tallest building in the world. It is a reinforced concrete structure up to 586 m (1923 ft). The concrete was transported by a single pump up to this height.¹¹ During the construction of the steel structure on top of the concrete structure, Samsung engineers found that erecting the last 242 m (794 ft) was very painful, time-consuming, and very costly because they had only two cranes to do so.

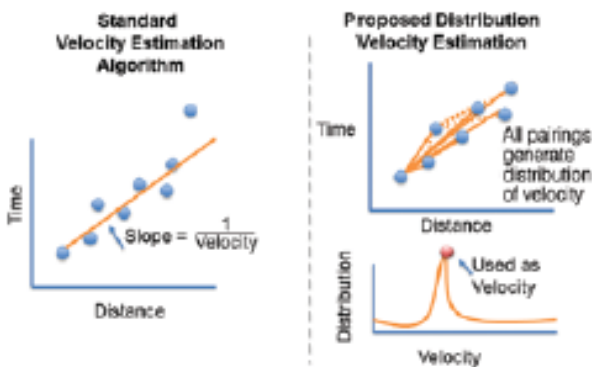
Fig. 4: Wave velocity estimation techniques: (a) the standard wave velocity algorithm computes velocity by taking the best fit line of the time versus distance data pairs and then takes the inverse of that slope; and (b) the proposed array technique computes velocity as the mean value of a velocity distribution, where this distribution is composed of velocity measurements obtained from all possible unrepeatable time versus distance data pairs

During this investigation, it was observed that variability in the velocity estimation method has a major influence on the generated reconstructed images. As an example, the uncertainty in estimating the bridge deck thickness (shown in Fig. 3(b)) from two different measurement sets can be directly related to variability of the measured wave velocity. The standard velocity estimation algorithm was conceived assuming that a small set of manual measurements are collected using a single sender and receiver. This procedure is schematically illustrated in Fig. 4(a). The use of multi-sensor arrays changes the nature of the collected measurement data set and opens the potential for improved velocity estimation algorithms. Several new velocity estimation schemes were considered, based on the same data sets that were collected from the bridge deck, that take advantage of the multi-sensor array data set. The most promising method was based on nearest neighbor image processing techniques.⁹ The same time versus distance paired dataset used by the standard method shown in Fig. 4(a) is considered. However, instead of fitting a line to the entire time versus distance dataset as the standard method does, the proposed method computes velocity measurements from each and every possible unrepeated time versus distance data pair, creating an approximately normal distribution of velocity results. After clipping the distribution for outliers outside the intentionally broad velocity range of 2000 to 4000 m/s (6500 to 13000 ft/s), the mean of the remaining distribution was used as the wave velocity estimate. An overly broad velocity range was used to avoid clipping any plausible velocity estimates. This improved method is schematically illustrated in Fig. 4(b).

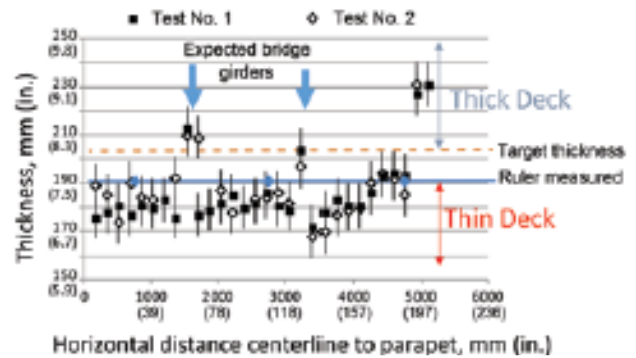
Fig. 5: Recomputed thickness profile using same dataset in Fig. 3. Test No. 1 and Test No. 2 present ultrasonic estimated thickness (using distribution velocity algorithm); the dashed orange line represents target design thickness; and the blue line represents ruler measurements in fresh concrete at the locations indicated by the blue diamond markers

the deck. New error bars (interval of confidence) associated to the proposed method were computed using the same procedure and dataset as previously explained. The new method's error bars were found to be ± 9 mm (0.35 in.), or about 4% of the total design thickness of 228 mm; these were superimposed onto each thickness measurement in Fig. 5.

The agreement between the repeated measurements is improved over that shown in Fig. 3(b), and the predicted thicknesses are within the laboratory-measured confidence intervals. The average repeatability error between the two measurements was decreased by 57% to 6 mm (0.24 in.). The measured ultrasonic thickness predictions match those from the field ruler measurements at the three locations. The agreement with the fresh concrete measurement gives confidence in the predicted thickness of the deck at those

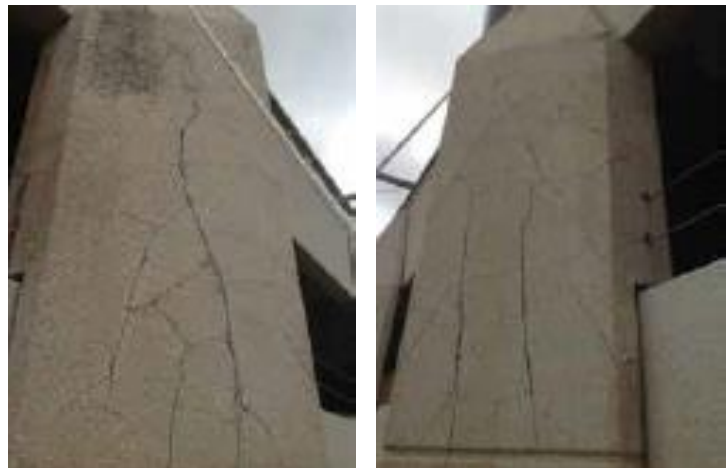
Fig. 1: Cracked load-bearing columns
