MYCONCRETE

THE BULLETIN OF THE AMERICAN CONCRETE INSTITUTE - MALAYSIA CHAPTER (E-bulletin)

Volume 13, Issue 10 | October 2022

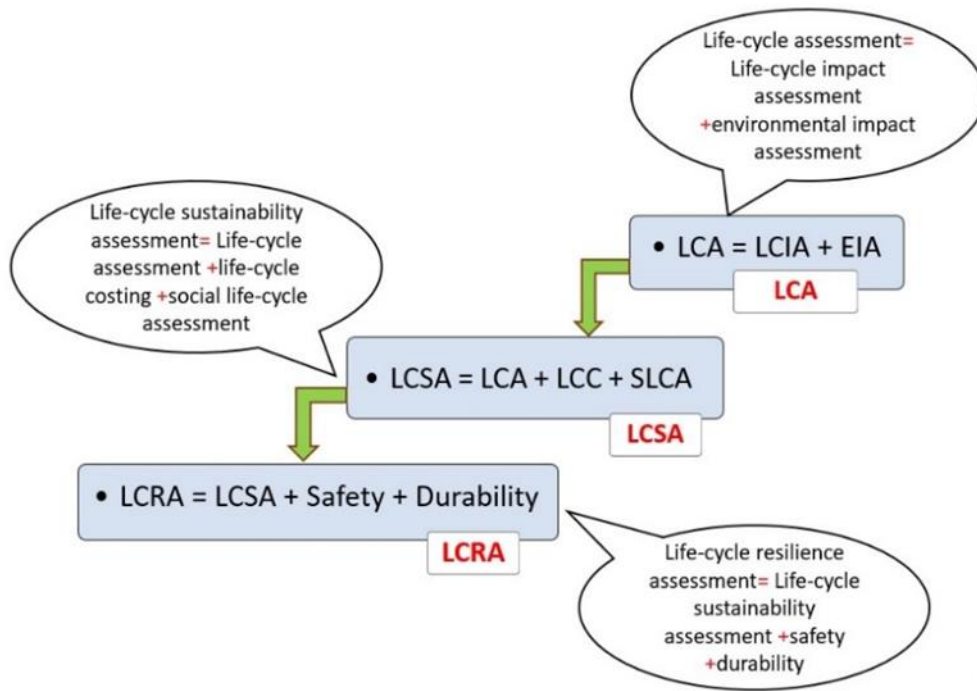
Figure 1. The stages of hierarchical formation of the LCRA framework

To assess the energy consumption and environmental impacts of concrete structures, a novel LCRA method which combines the aspects of sustainability, durability, and safety of structures, has been introduced and adopted in this study (Figure 1).

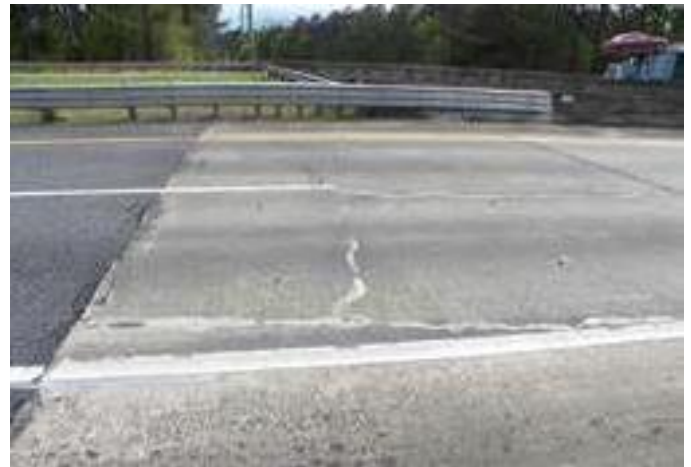
Fig. 1: The east-side bridge approach slab of westbound I-10.

The project involved the replacement of the existing approach slabs in the westbound direction on Bridge No. 500077 on I-10 (Florida SR 8), over the Apalachicola Northern Railroad near Quincy, FL¹. The existing cast-in-place approach slab had been in service since the bridge was constructed in 1976, and it was exhibiting cracking and settlement (Fig. 1).

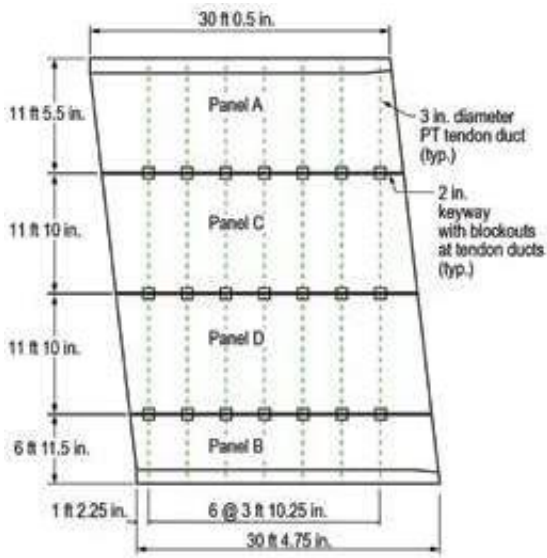
Fig. 3: Panel layout and post-tensioning duct locations at the I-10 bridge approach slab (Note: 1 ft. = 0.3 m ; 1 in. = 25 mm)

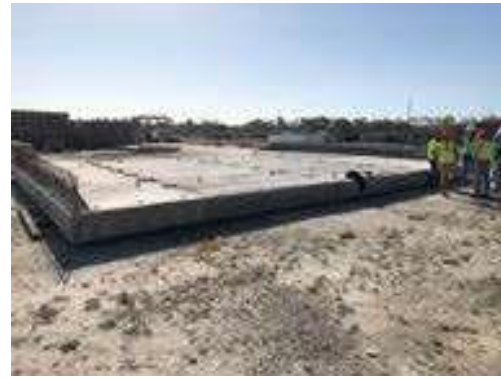
Fig. 4: Panel fit-up was verified at the precast plant on March 27, 2018.

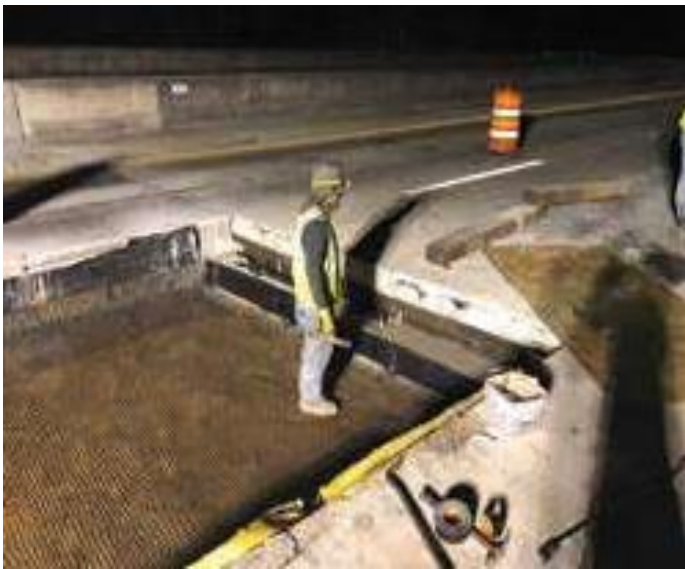
Fig. 5: The backwall seat was prepared by removing unsound concrete, repairing the seat with a high-early-strength patching material, drilling holes for the panel anchor dowels, and installing neoprene bearing pads.

- Removing the existing slab section for the lane being replaced;
- Removing the existing base;
- Preparing the backwall seat (Fig. 5);
- Grading and compacting the sub-base;
- Placing a geogrid over the sub-base;
- Placing, compacting, and grading a new base;
- Placing a double layer of polyethylene sheeting over the base;
- Placing steel bearing plates on the sheeting (Fig. 6);
- Placing the precast panel while maintaining the longitudinal joint widths as specified;
- Adjusting the elevation of the panel, using levelling screws, to the specified surface elevation;

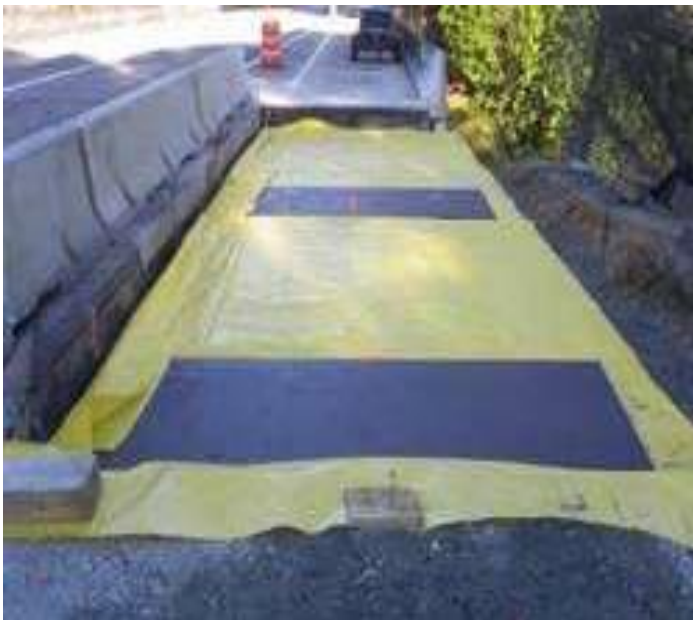
Fig. 6: Bearing plates were placed over two layers of 12 mil (0.31 mm) polyethylene sheet. The bearing plates were positioned to match the location of levelling screws in the panels.

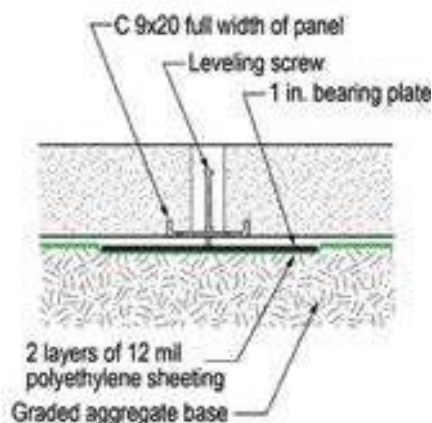
Fig. 7: Levelling screw schematic (Note 1 in. = 25 mm; 12 mil = 0.31 mm)

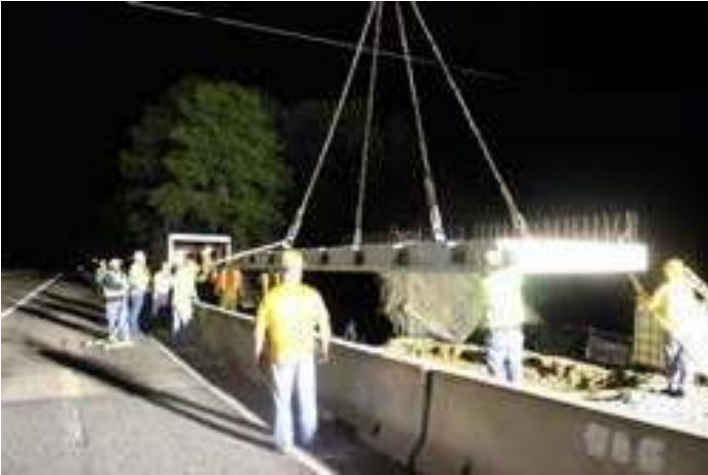
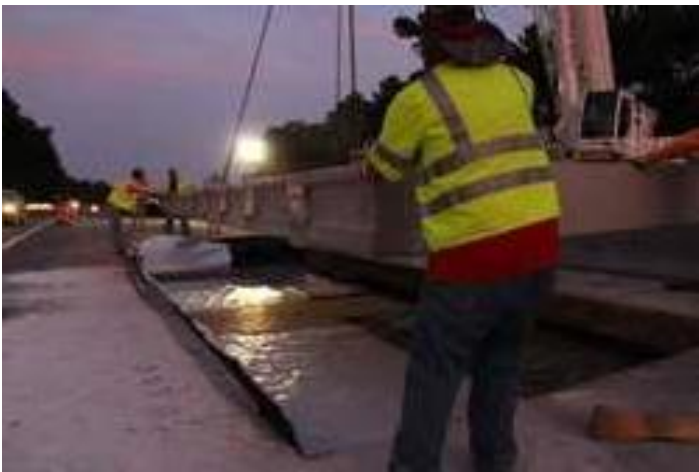
Fig. 8: Panel installation: (a) Panel A; and (b) Panel C

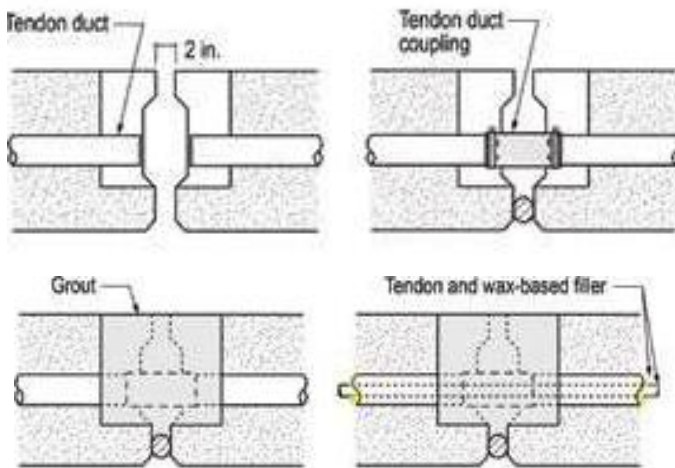
Fig. 9: The keyways and tendon ducts were designed to prevent leakage or blockage: (a) block-outs provided access to the tendon ducts; (b) a backer rod was installed over the length of the keyway and the tendon ducts in adjacent panels were coupled; (c) keyways were grouted after Panels C and D were installed; and (d) after all panels were in place, the tendons were installed, tensioned (starting from the center of the group), and protected with a wax-based filler (Note: 1 in. = 25 mm).

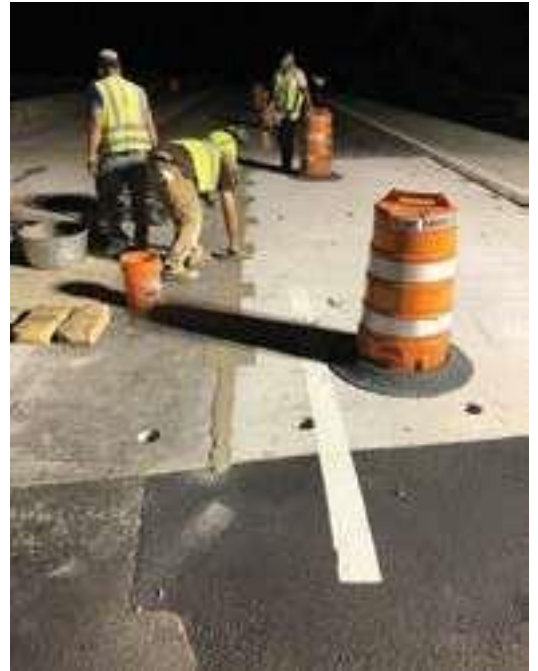
Fig. 10: Workers finish the keyway grout at the conclusion of a panel installation.

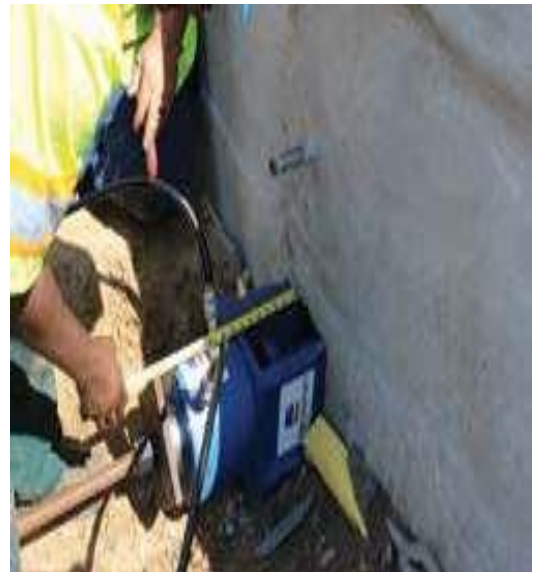
Fig. 11: A worker checks tendon extension during the tensioning operation

The post-tensioning tendons comprised seven 1 in. diameter bars, spaced at 3 ft. 10.25 in. (1.2 m). Final applied load per bar was 57,800 lbf (257 kN). To ensure adequate corrosion protection for the tendons, the specification required verification that the tendon duct system was leakproof and that the ducts could be completely filled with wax-based filler. The ducts were successfully tested on June 26, 2018, and the tendons were stressed on June 27, 2018. Figure 11 shows the post-tensioning jack applying load at an anchor plate.

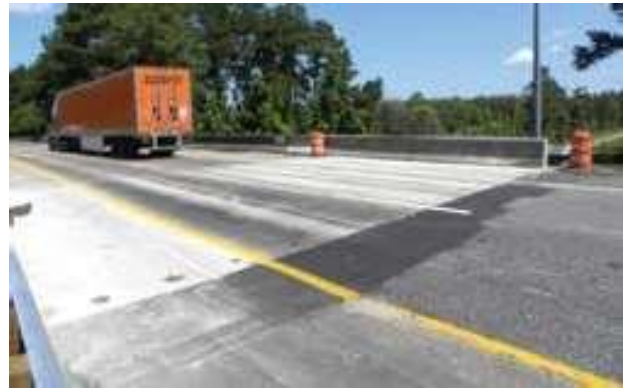
Fig. 12: Completed bridge approach slab

The specification required that the bedding grout have a minimum 28-day compressive strength of 5500 psi. The bedding grout was installed under the panels after the tendons were tensioned. After all *finishing and clean-up* activities were completed, a coating of high-molecular-weight methacrylate was applied over all four panel surfaces to seal the concrete. The completed bridge approach slab is shown in Fig. 12.

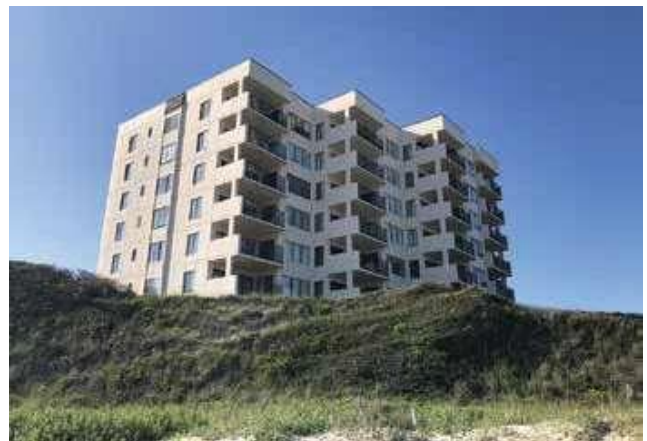
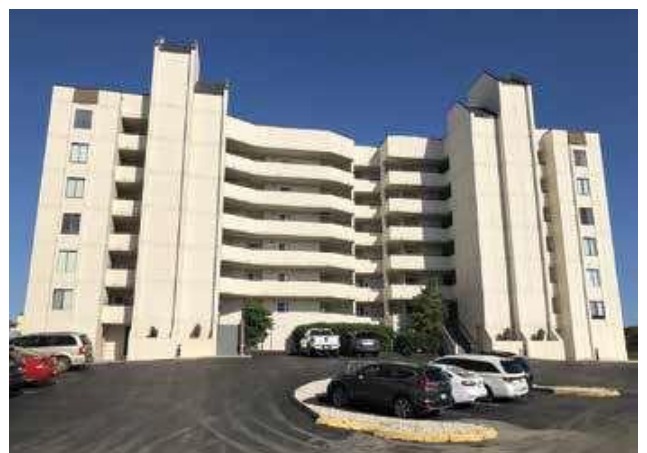
Fig. 1: Sound of Sea II Condominiums. (a) viewed from the beach; and (b) viewed from the parking lot in 2019 (more than 10 years after repairs).

Constructed in 1984, Sound of the Sea II is a six-level reinforced concrete condominium building with 36 individually owned units. It is on the 0.75 mile (1.2 km) wide Bogue Banks Island within a few hundred feet of the Atlantic Ocean in Emerald Isle, NC, USA. It includes exterior common access corridors (walkways) on the front side of the building and private balconies for each unit (Fig. 1).

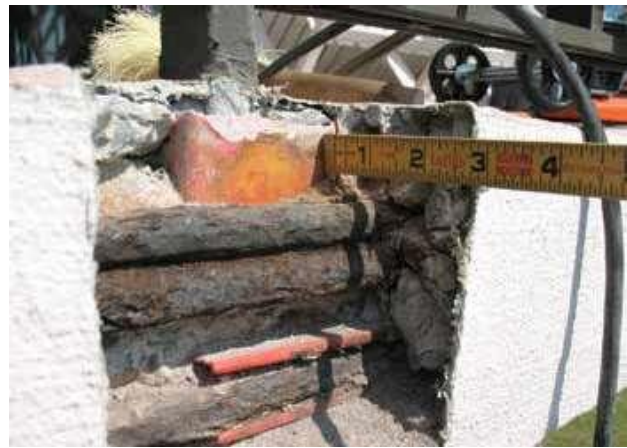
Fig. 2: Example of test excavation during 2007 assessment

In 2007, excavations were made as part of the design effort to review embedded steel and structural conditions. Core samples were extracted from one corridor area and one balcony for resistivity testing by a third party. Resistivity was found to be relatively low and thus conducive for active corrosion for both samples. Of note, the balcony sample (4800 ohm-cm as received; 3000 ohm-cm after 12 hours of saturation and removal from bath) had about 60% the resistivity of the sample taken from the corridor (7700 ohm-cm; 4700 ohm-cm). Excavations revealed significant reinforcing steel corrosion (Fig. 2).

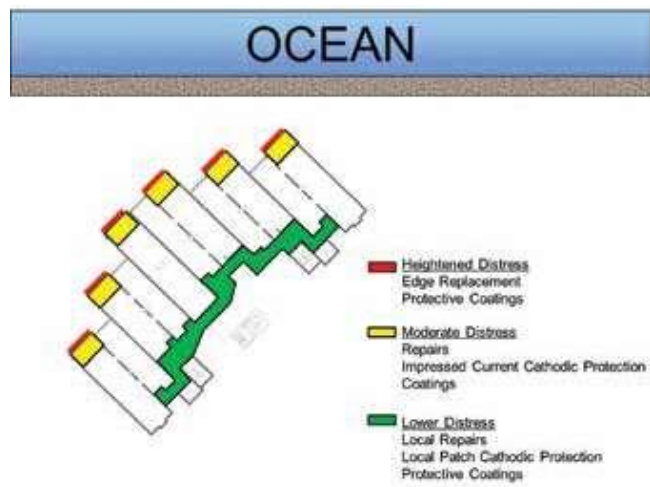
Fig. 3: Schematic showing tower position and final repair strategy

Budget was of the utmost importance to the owners. Thus, it was necessary to evaluate repair/preservation options that would extend service life but not be overconservative and cost prohibitive. The designers discussed the merits of global ICCP and GCP with the owners. Given the spatial differences in exposure, identified differences in magnitude of distress, budgetary constraints, and the owners' directives, two separate approaches for repair and protection were adopted. Concrete repair—an alternate for ICCP—and cementitious deck coatings were specified for balconies where distress was more severe. Limited concrete repairs, urethane deck coatings, and an alternate for localized GCP were specified for corridors where distress was more sporadic and exposure somewhat less severe. Alternates were provided in the bid for CP to provide flexibility for the owners. A general overview of primary repairs to the corridors and balconies is summarized in Fig. 3.

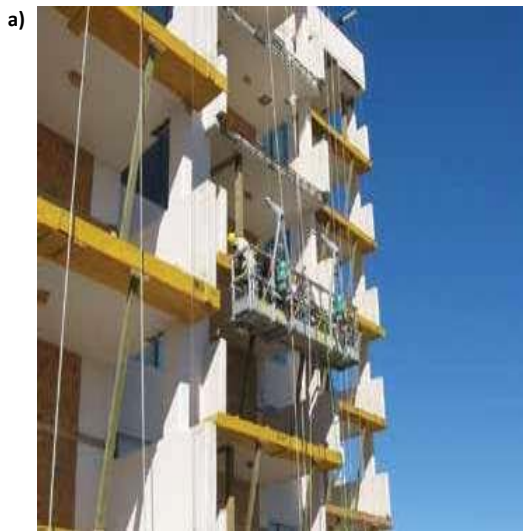
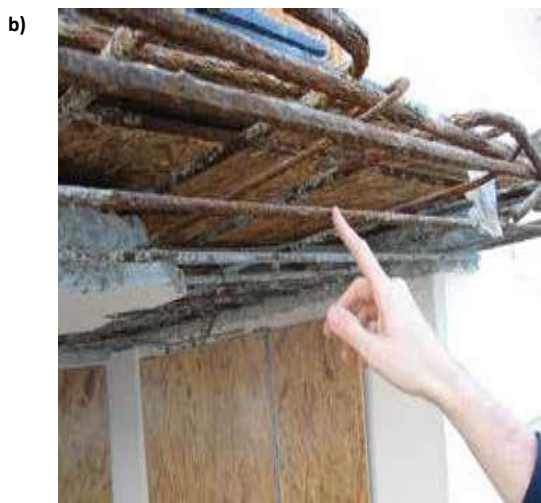
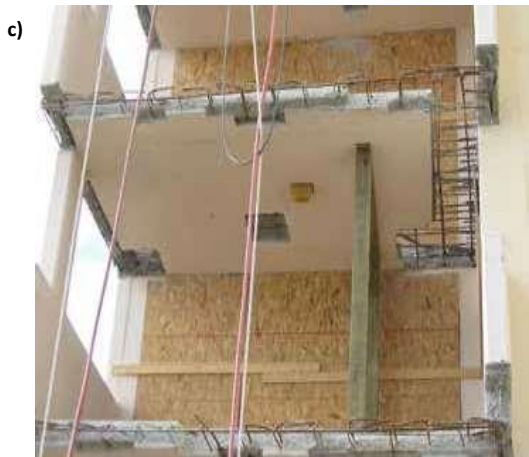
Fig. 4: Balcony repairs:
 (a) general construction access with visible swing stage;
 (b) extent of distress; and
 (c) one of the more severely distressed balconies requiring shoring.
 Note demising walls at balcony sliding glass doors.

Swing stages were used for balcony access (Fig. 4 (a)). Due to project logistics and the amount of uncovered distress (Fig. 4(b)), it became immediately evident that the most efficient and cost-effective manner to address slab edges was to remove the entire slab edge. Although some sound concrete was removed, this method was less complicated and allowed for more efficient installation of supplemental reinforcement to address severely corroded reinforcing steel. It also allowed for effective coordination and installation of drip edges and guardrail posts after repairs. A significant challenge to the project was to minimize damage to guardrails during removal, storage, and reinstallation, and to make sure that slab edge installation was coordinated with new precisely located post pockets.

In general, less concrete removal than typical was necessary due to the use of ICCP. However, some balconies required full-depth repairs over substantial areas that required temporary support (Fig. 4(c)). Finite element analysis was used during the project to evaluate conditions for making field decisions. Mechanical splices and adhesive anchors were used where severely corroded reinforcing steel or inadequate steel was encountered and limited space was available for lap splicing. This also allowed for reduced quantities of concrete removal.

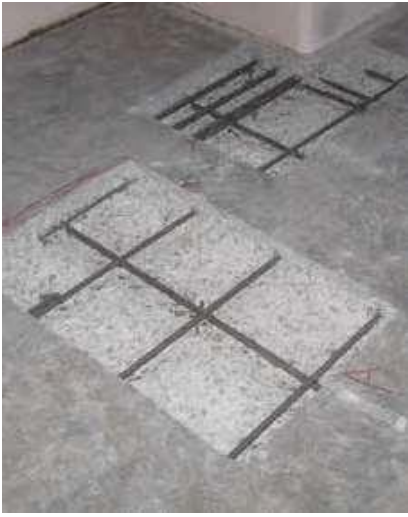
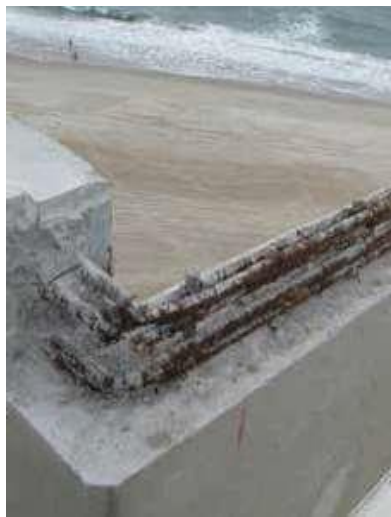
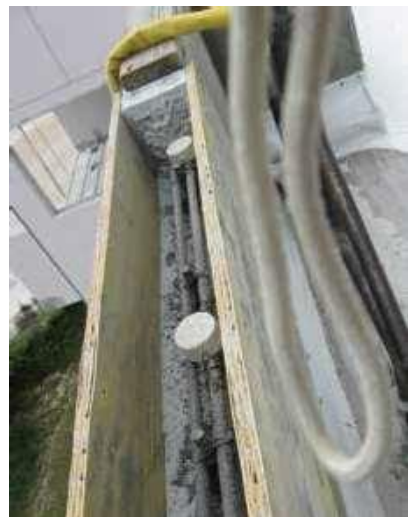
Fig. 5: In progress repairs: (a) exposed reinforcement in corridor; (b) exposed reinforcement in parapet; and (c) GCP and formwork installed at parapet repair.

Lift and foot access were used on corridors. Repairs at corridors (Fig. 5(a)), columns, and walls were less frequent and generally smaller than those at balconies. Repairs at roof parapets (Fig. 5(b) and (c)) were variable. Commercially available alkali-activated galvanic zinc anodes were embedded in patch repairs to help prevent incipient anodes directly outside repair areas and associated distress. Anodes were tied to reinforcing steel within patches and all reinforcing steel and anodes within patches were confirmed electrically continuous. Reinforcing steel was coated with a cementitious/epoxy anticorrosion bonding agent. This had the likely added effect of diverting current from the anode to the existing substrate concrete.

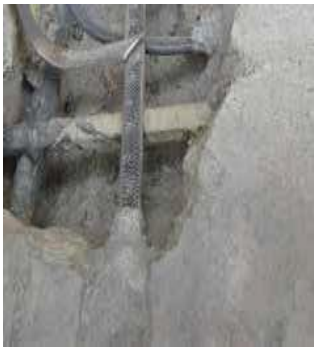
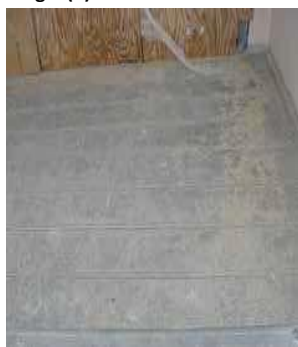
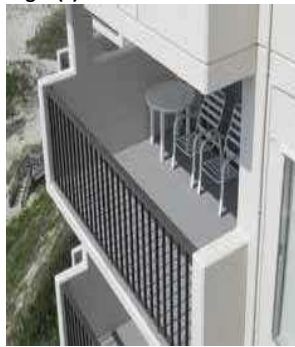
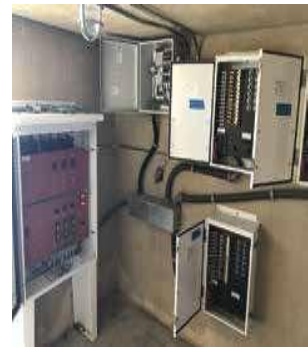
Fig.6: ICCP system features: (a) anode and isolation from low-cover reinforcing bar; (b) grouted anode slots; (c) balcony deck as finished with vertical conduit (photo taken 2010); and (d) control and power system components (May 20, 2019).

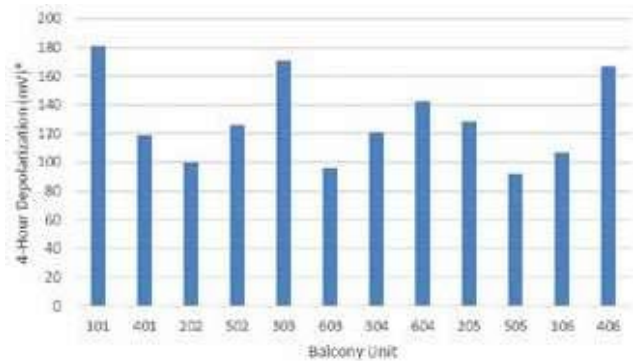
Fig. 7: Four-hour depolarization (September 25, 2008) (Note; Unit 505-97 mV at 6.25 hours; Unit 603-102 mV at 5.25 hours)

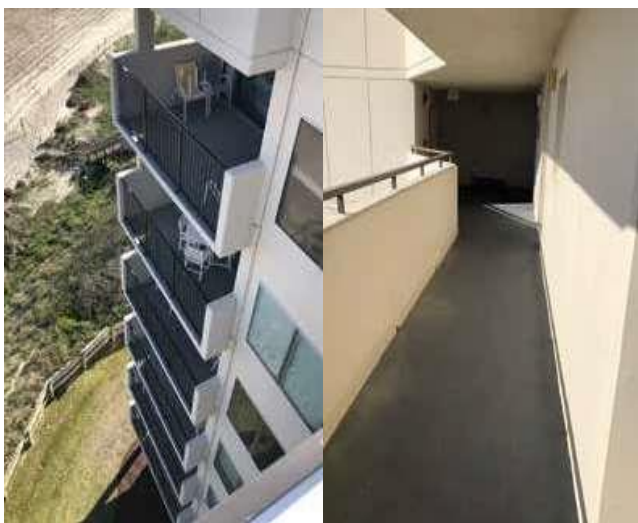
Fig. 8: Typical balconies and corridor area as of May 20, 2019.

During visits in 2019, it was observed that critical ICCP system components were functioning to protect reinforcing steel within the original design parameters. While some small discrete corrosion stains and one small delamination were observed on balcony soffits, likely associated with discontinuous steel embedments, no major concrete distress was observed on balconies repaired and protected with ICCP in 2007/2008. The remote monitoring device had its backup battery replaced as part of routine maintenance, and the site-monitoring device and wiring conduits on the roof required maintenance after a recent major hurricane; however, these items have not affected protection. Guardrail anchorages in the concrete from the 2015 guardrail replacement project had variable connectivity, demonstrating the need for coordination of all repairs to concrete subjected to ICCP. Some concrete distress was observed on walkway areas and roof parapets where ICCP was not installed, and some isolated deck coating damage was observed, but installed repairs and coatings generally have performed well. Balconies and corridor areas as of May 2019 are shown in Fig. 8.
