THE BULLETIN OF THE AMERICAN CONCRETE INSTITUTE - MALAYSIA CHAPTER  
(E-bulletin)

Volume 13, Issue 11 | November 2022

## **MyConcrete: The Bulletin of the American Concrete Institute – Malaysia Chapter**

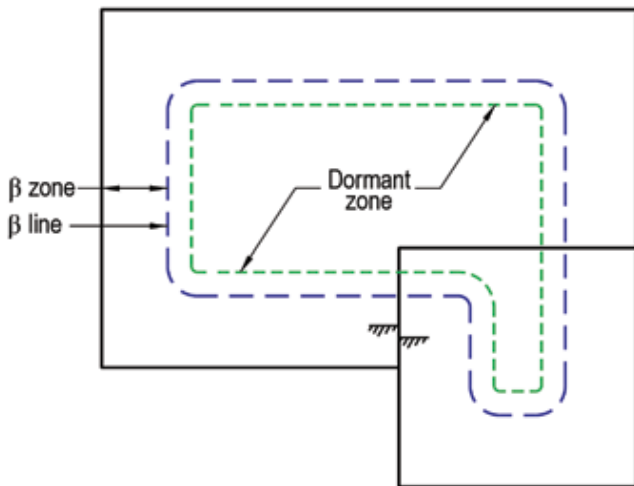
Fig. 3: The  $\beta$ -line is the approximate location of maximum moment. The dormant zone is the area of small moments and shears

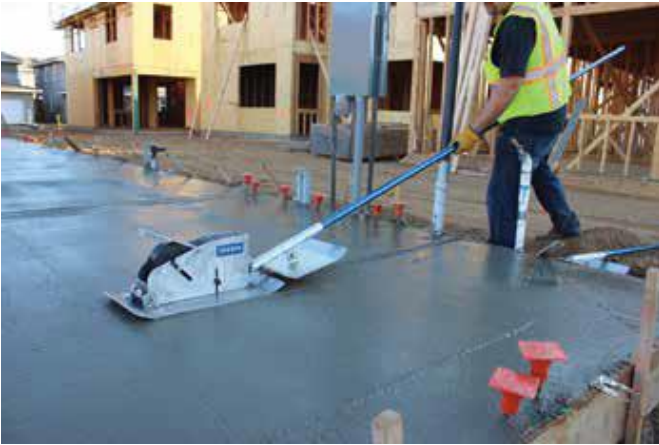
**Fig. 5:** This manually operated tool is used to embed a polymer tape into fresh concrete. The tape creates a stress concentration in the hardened concrete, typically resulting in a relatively straight crack that opens as the concrete shrinks (photo courtesy of Aaron Hilbert LLC)

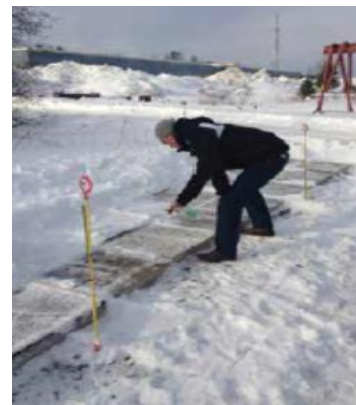
**Fig. 2:** Spraying slabs with NaCl solution at the UNB exposure site

Larger test specimens were also produced for placement on field exposure sites. One 600 x 600 x 100 mm (24 x 24 x 4 in.) concrete slab was cast for each mixture and cured under wet burlap and plastic for 24 hours, after which the slabs were demolded and moist cured at room temperature for an additional 6 days. Specimens were then placed in laboratory air to dry for 21 days before being transported to the University of New Brunswick (UNB) exposure site. After each snow event, the snow was cleared from the top of the slabs and the surface was sprayed with 180 mL of 30 g/L NaCl solution (Fig. 2).

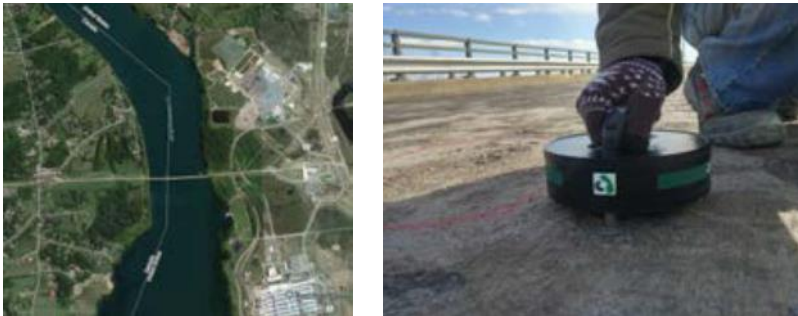
**Fig. 1: The Three Nations Bridge was evaluated using visual, acoustic, and electrochemical measurements: (a) aerial view of Cornwall Island, ON, Canada (left) and Akwesasne, NY (right); and (b) closeup of the device used to take electrochemical measurements**

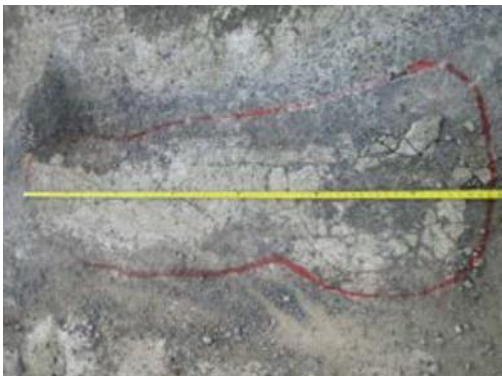
**Fig. 3: An example of a damaged area on the Three Nations Bridge**

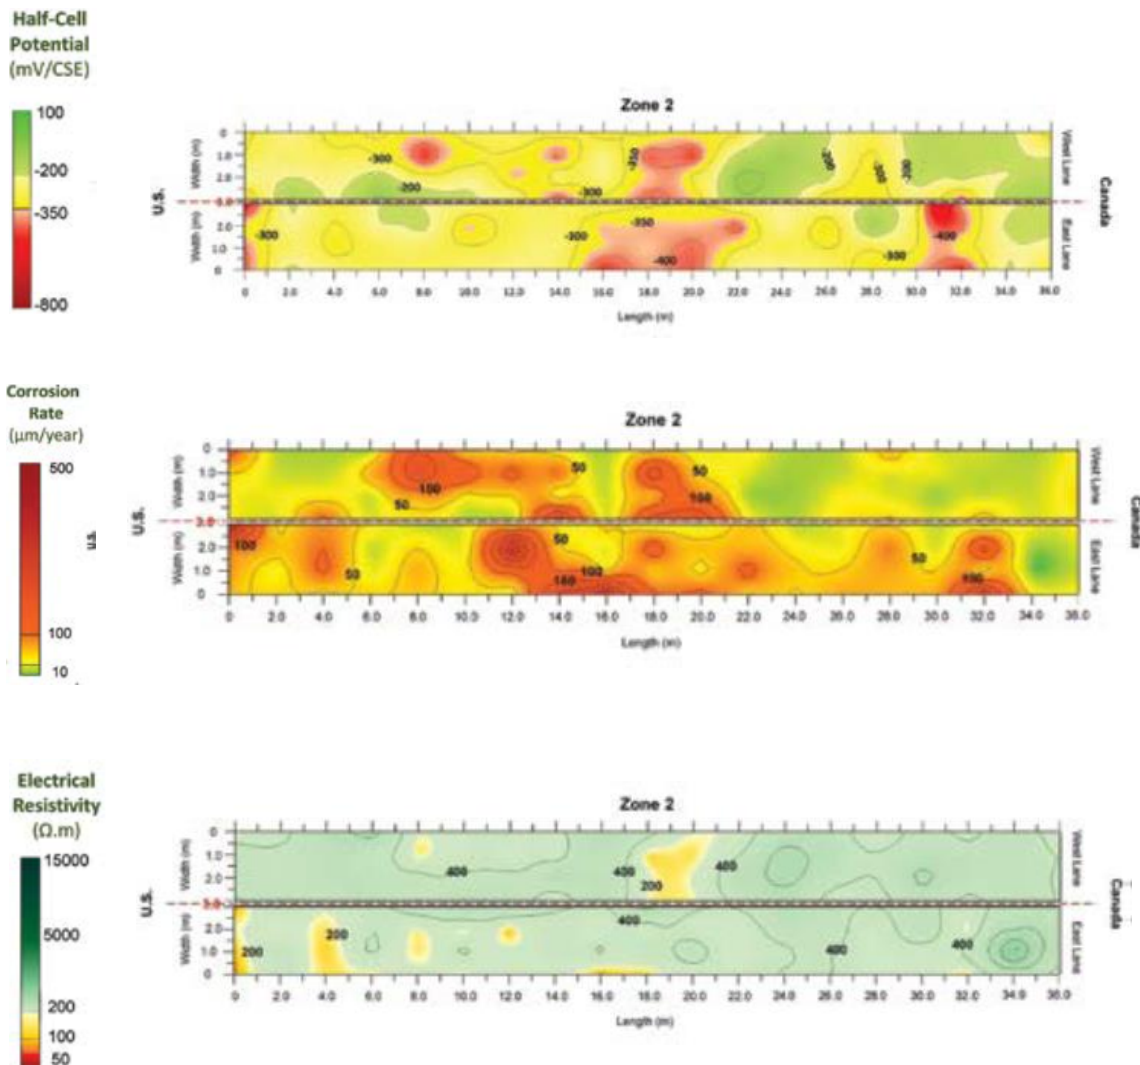
Fig. 5: Corrosion potential, corrosion rate, and electrical resistivity contour maps of the Three Nations Bridge

Figure 5 shows resistivity, corrosion potential, and corrosion rate results. In general, both corrosion rate and corrosion potential tests identified similar high-risk zones—namely, in the middle of the investigated zone and in the East zone near both U.S. and Canadian sides. The resistivity values recorded were generally in the range of 100 to 500 ohm·m, which, according to Table 1, indicates a low risk of corrosion.

However, it is well-established that resistivity is significantly influenced by the concrete moisture content during investigation. Therefore, these results are attributed to the dry condition of the slab

during the inspection. Nevertheless, the resistivity measurements were still able to detect anomalies (lower resistivity values) in the middle of the investigated zone and in the East lane near the U.S. border. This is in general agreement with the half-cell and corrosion rate results and is attributed to internal cracking or delamination caused by corrosion propagation.

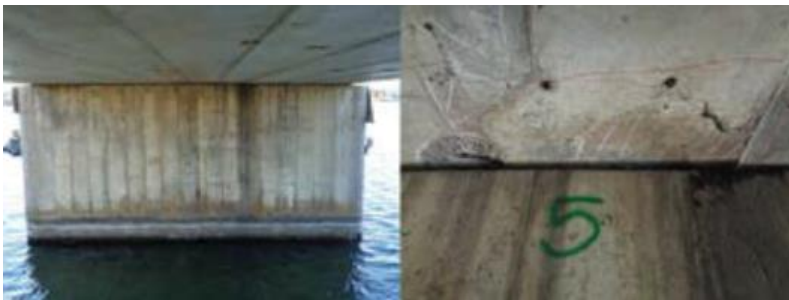
Fig. 6: The underside of the LaSalle Causeway bridge deck exhibited visible damage only near the central pier
