MYCONCRETE

THE BULLETIN OF THE AMERICAN CONCRETE INSTITUTE - MALAYSIA CHAPTER
(E-bulletin)

- 10** Challenges in Corrosion Management for Marine Infrastructure
- 18** The Challenges of Achieving Compatibility in Concrete Repair
- 27** A Tale of Two Dams

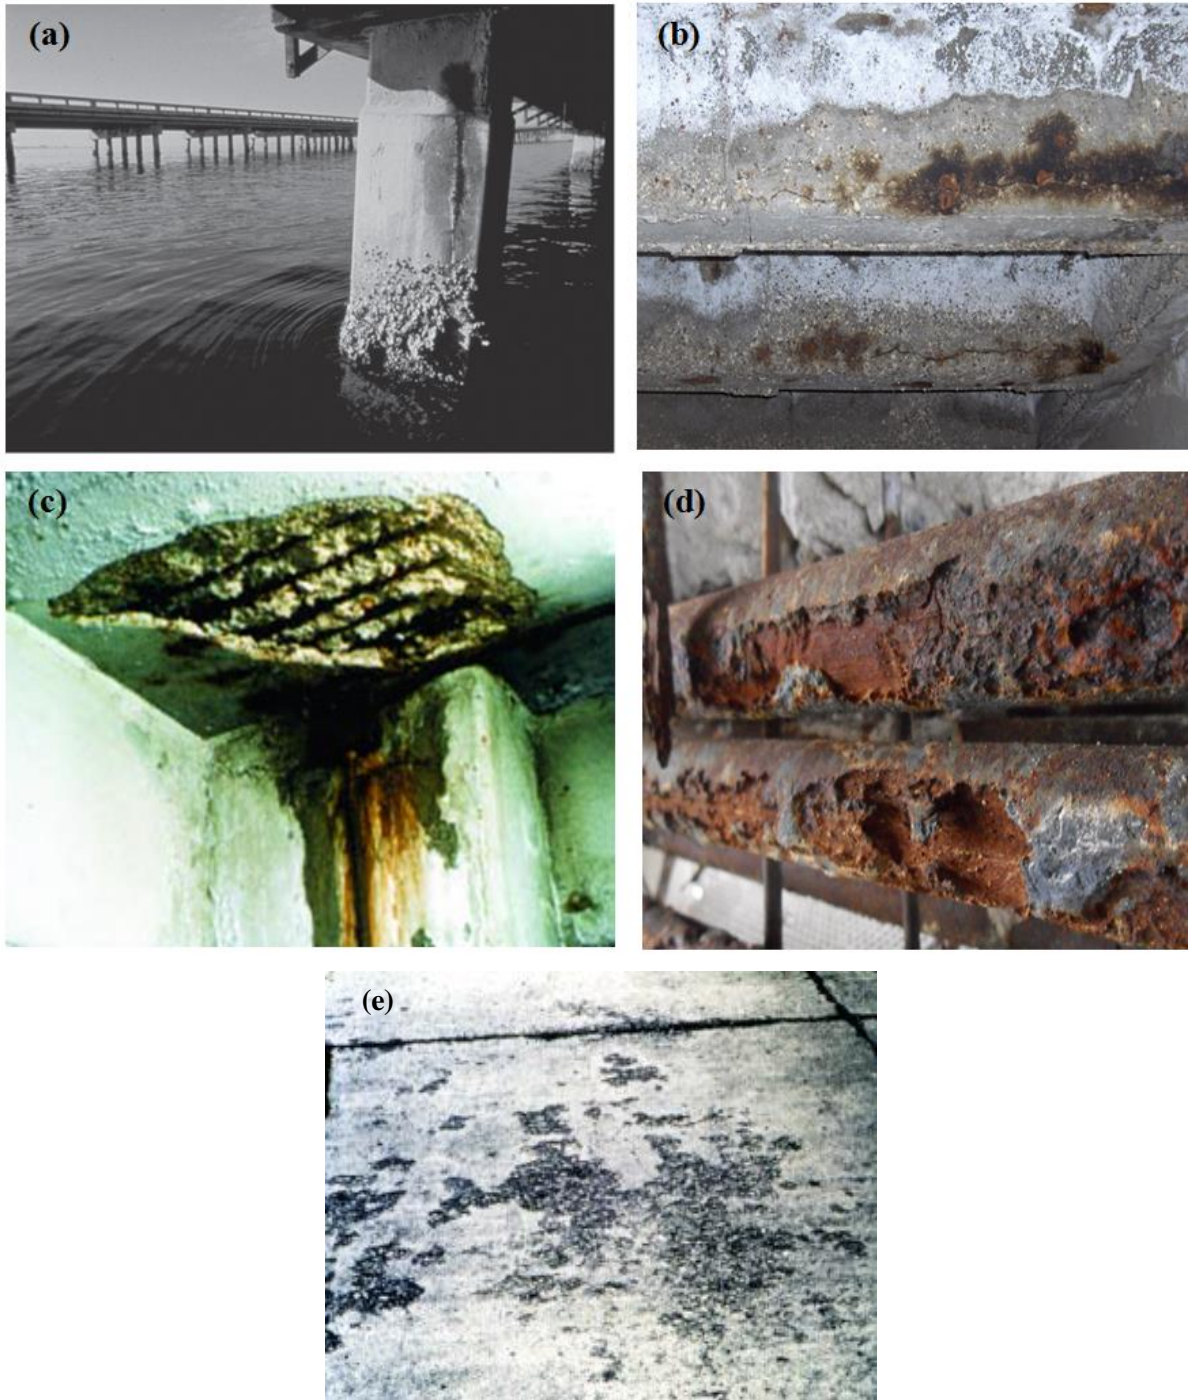
Figure 1: Example cases of primary mechanism of the deterioration by (a) cavitations, (b) sulphate attack, (c) reinforcement, (d) carbonation and (e) freezing and thawing

Since concrete structures are often exposed to a variety of conditions, maintaining the quality, original form and serviceability of reinforced concrete in the marine environment present more difficult challenges [4], [13], [14]. The primary mechanisms of the concrete deterioration can occur through concrete surface (abrasion, erosion and cavitations), reinforcement (corrosion of steel), aggregate (alkali-aggregate reactions, freezing and thawing) and cement-based matrix (seawater attack, salt crystallization, carbonation, acid attack, sulphate attack) as depicted in Figure 1 [6], [14] – [16].

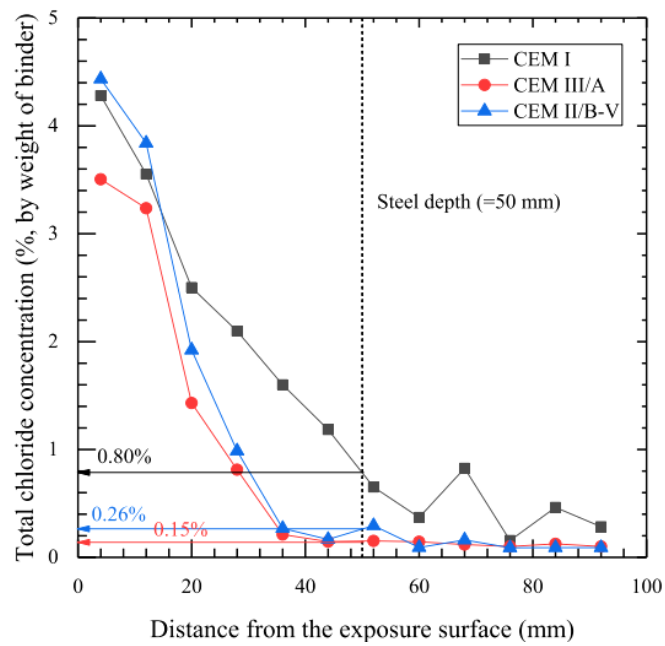
Figure 2: Chloride profiles through slabs after 18 years exposure [22]

In 2018, Kim et al. [22] studied the performance of reinforced concrete for marine environment by using three different types of cement with supplementary cementitious materials such as fly ash and ground granulate blast slag. The chloride diffusion coefficients obtained were $1.39 \times 10^{-12} \text{ m}^2/\text{s}$, $4.21 \times 10^{-12} \text{ m}^2/\text{s}$, and $4.21 \times 10^{-12} \text{ m}^2/\text{s}$ for CEM I, CEM III/A (cement + slag) and CEM II/B-V (cement + fly ash) concrete, respectively (Figure 2). Although CEM I concrete had the highest resistance, the CEM III/A (cement + slag) and CEM II/ B-V (cement + fly ash) still have the potential to be used as binder in resisting chloride ingress which is good in slowing down the corrosion process. Plus, supplementary cementitious materials can resist chloride transport due to disconnected pore structures caused by continuous hydration and high chloride binding.

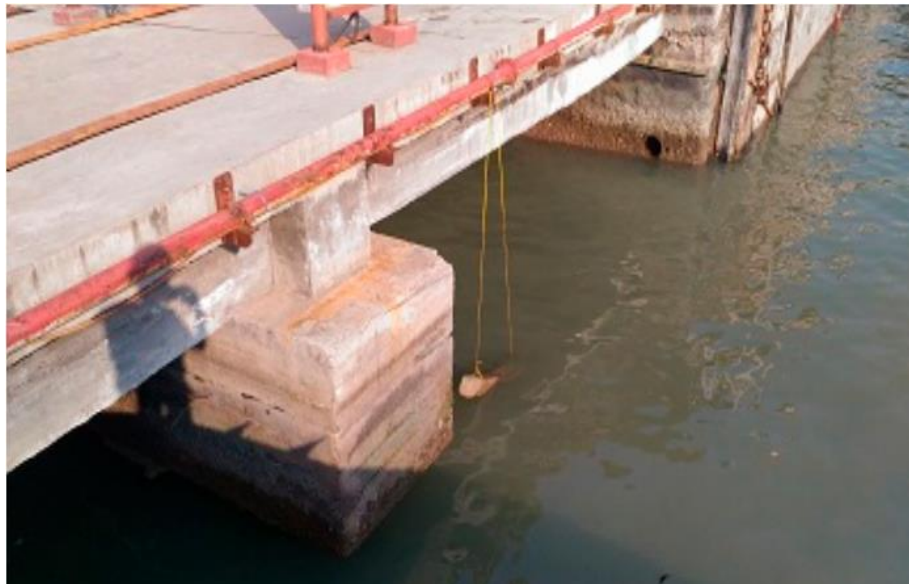
Figure 3: Geopolymer concrete beam cured in seawater for 28 days [32]

In 2019, Darmawan et al., [32] studied the behaviour of a geopolymer concrete for beam application using high calcium content fly ash (FA) considered by curing the specimen in a sea splashing zone for 28 days in marine environment (Figure 3). Based on this finding, geopolymer concrete has demonstrated good compressive strength (24.78 – 35.09 MPa) with no effect from the sea in terms of beam crack pattern and development. However, further tests on chloride migration coefficient and cover thickness are required to understand the effect of the marine environment on the geopolymer concrete in terms of the important parameters.

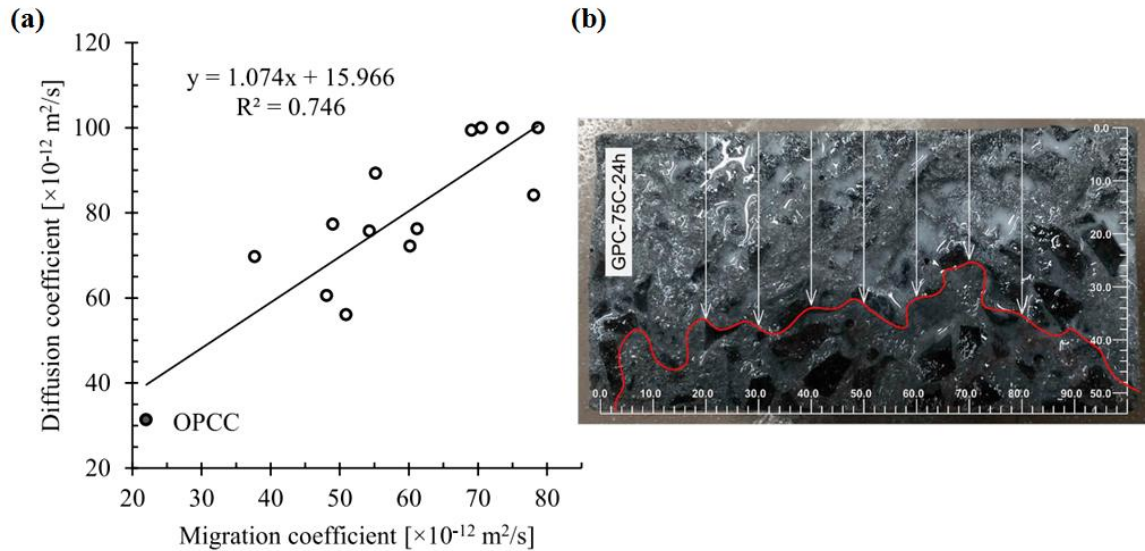
Figure 4: (a) Chloride diffusion coefficient versus chloride migration coefficient for GPCs and OPC (b) Example of chloride penetration depth test (NT BUILD 492) [33]

In 2020, Noushini et al., [33] studied the effect of chloride diffusion of low-calcium fly ash-based geopolymer concrete prepared using different heat curing conditions for durability in marine environment. A reduction in migration coefficient was observed from the increase in heat curing temperature and duration. The chloride migration coefficients of the studied fly ash-based GPCs

were significantly higher than that of OPC based concrete reported in the literature. Results showed that the chloride diffusion resistance and the chloride binding capacity of fly ash-based geopolymer concrete are very low (Figure 4). The values of non-steady-state migration coefficients for fly ash based geopolymer concrete ranged between $38 \times 10^{-12} \text{ m}^2/\text{s}$ and $79 \times 10^{-12} \text{ m}^2/\text{s}$.

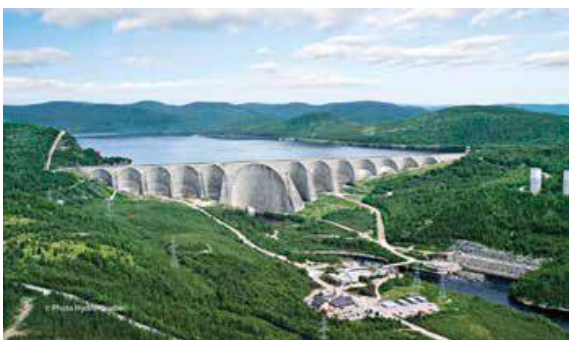
Fig. 2: Daniel-Johnson Dam and Manic-5 Generating Station in Quebec, Canada (photo courtesy of Hydro Québec)

I believe the failure had its origins, at least partially, in the selection of the dam type. For support, I will compare Oroville Dam, which was built by the California Department of Water Resources (DWR), to Daniel-Johnson Dam (originally called Manicougan 5 or simply Manic-5), built by Hydro Québec in Canada (Fig. 2). Both dams produce hydroelectric power (the installed capacity of Oroville Dam and Daniel-Johnson Dam is 819 and 1528 MW, respectively), and both were built at the same time, in the 1960s.

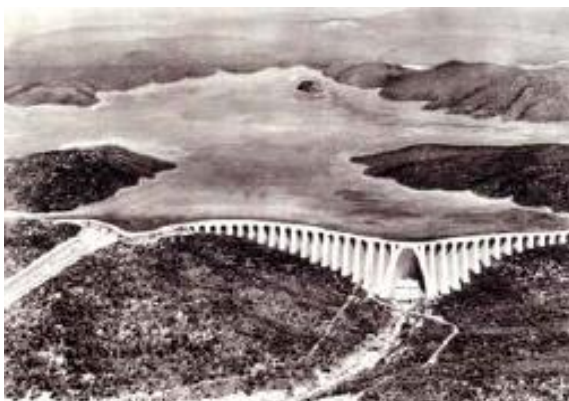
Fig. 3: Artist’s rendering of Andre Coyne’s multiple arch concrete dam design for the Oroville site (based on Reference 10)

The Portland Cement Association (PCA) retained Coyne to visit the site by helicopter and to devise a design for a concrete dam that would be the most cost effective at the Oroville site. His design proposal consisted of an attractive multiple arch dam (Fig. 3). This design would require less concrete, but it would also require more forming than a typical concrete gravity dam. However, labor for building and erecting forms was relatively cheap at that time in history.
